Spa Inspection/Leak Detection Report

June 24, 2021

280 Mahoney Dr. Telluride, CO 81320

Lulu City Condominiums HOA

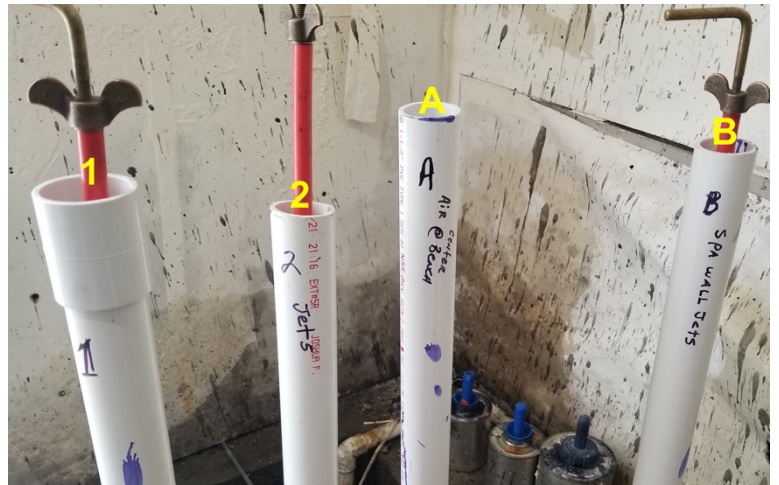
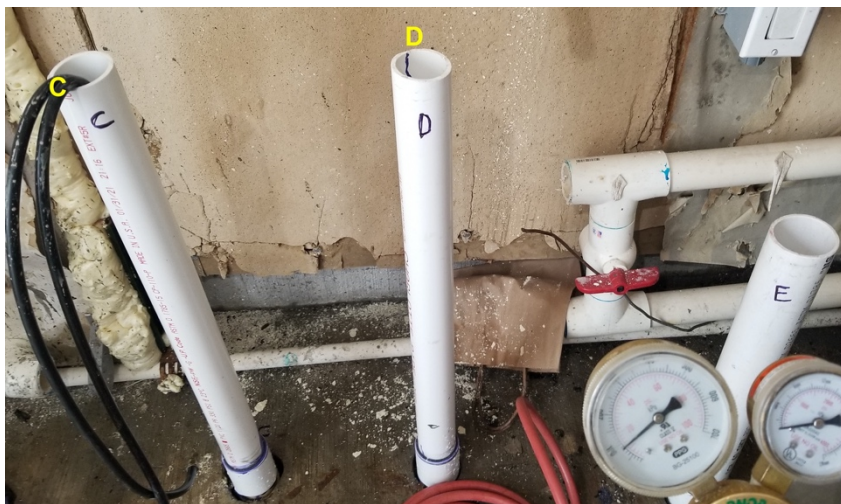
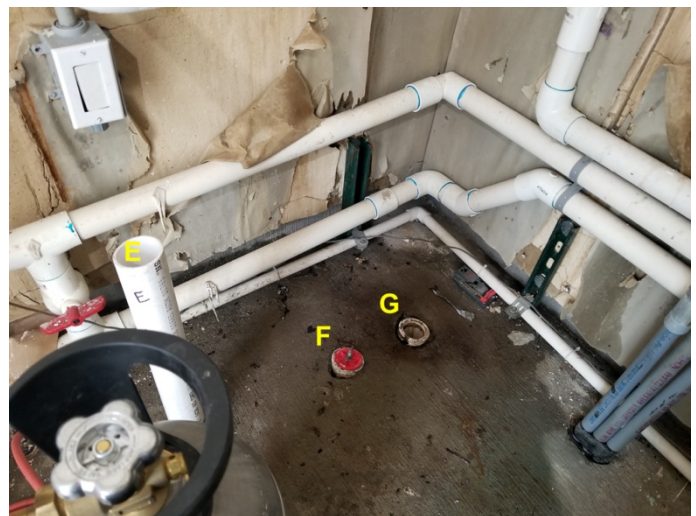
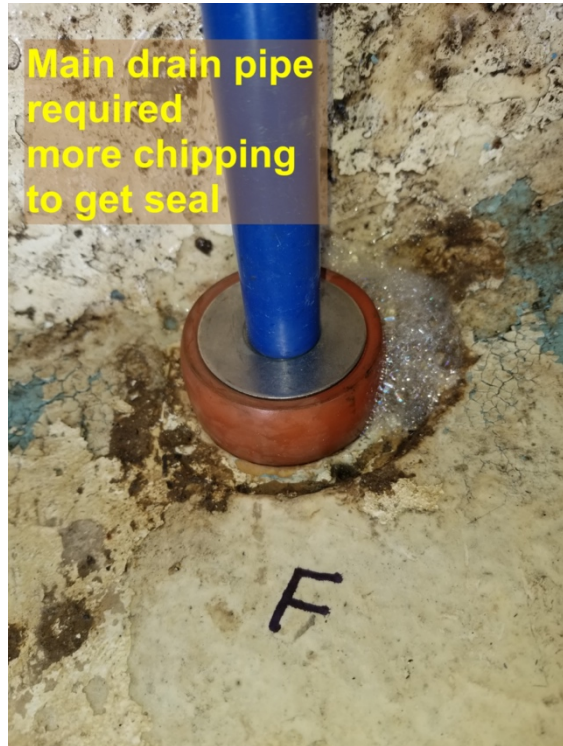
Equipment Room Piping

Determining what pipe did what in the equipment room was determined as a matter of course in performing the pressure testing, although their purpose should be re-confirmed prior to replumbing the spa. In particular, two separate banks of jets are connected by shared air supply piping inside of the spa's concrete shell. Designating one of the pipes as the air supply pipe is only a best-guess at this time. Also, one pipe holds pressure with no plugs in the spa. We don't know what this pipe was for, but it seems abandoned and is not required to operate the spa.

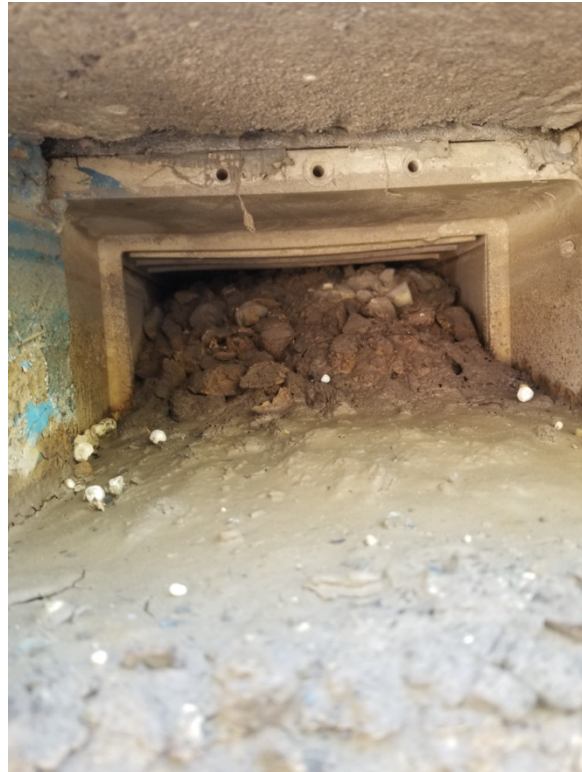
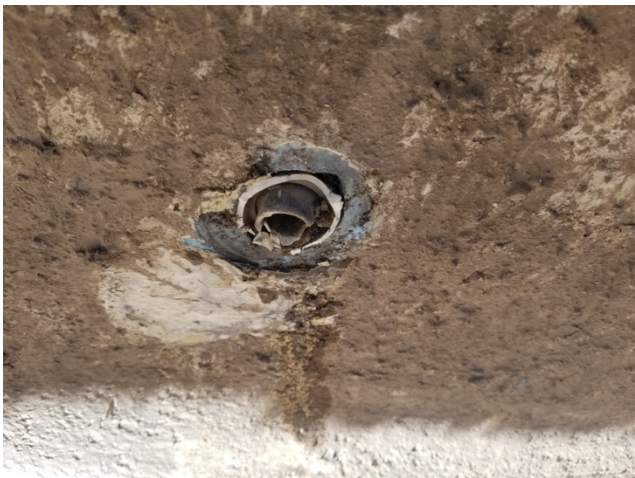
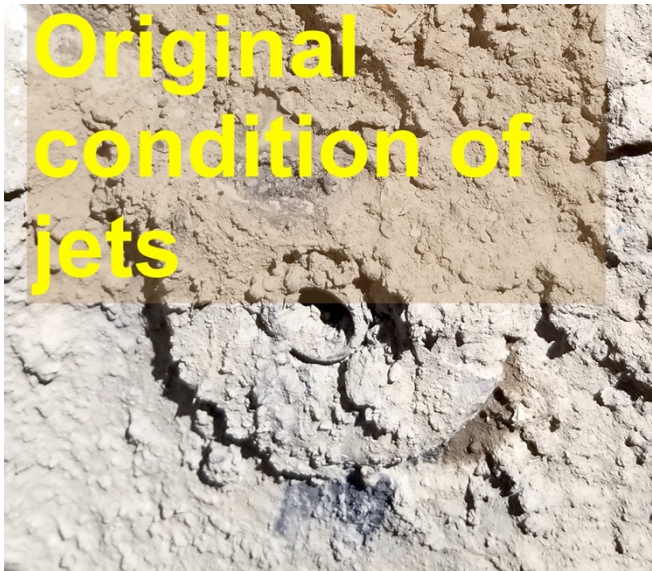
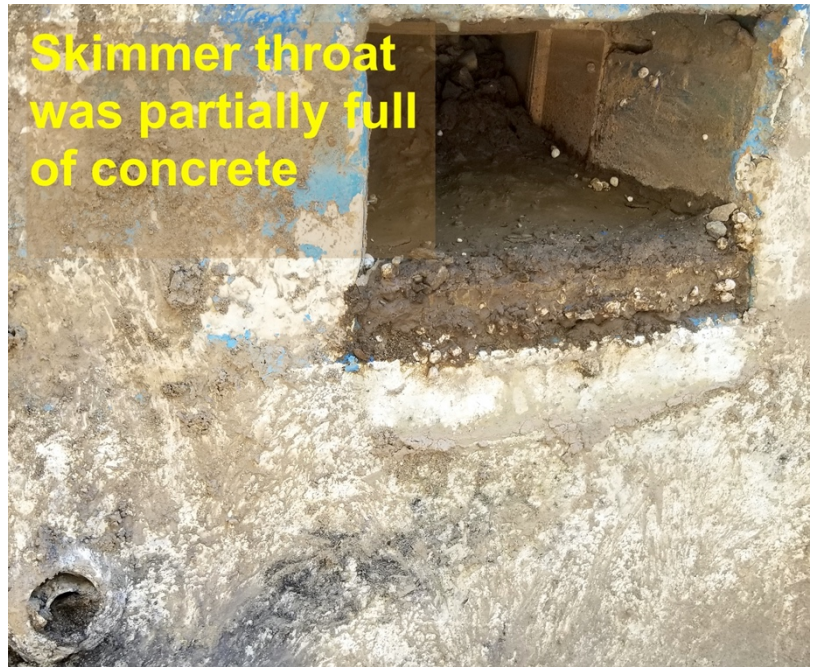
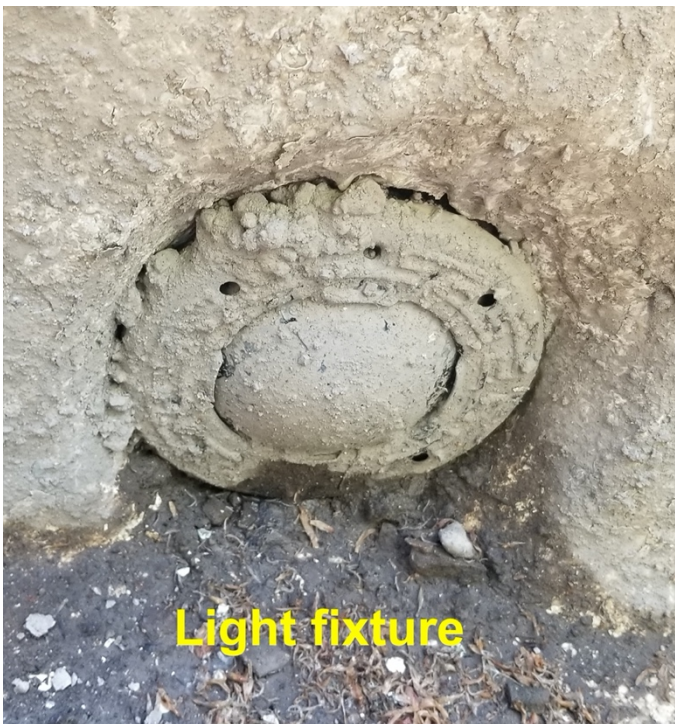
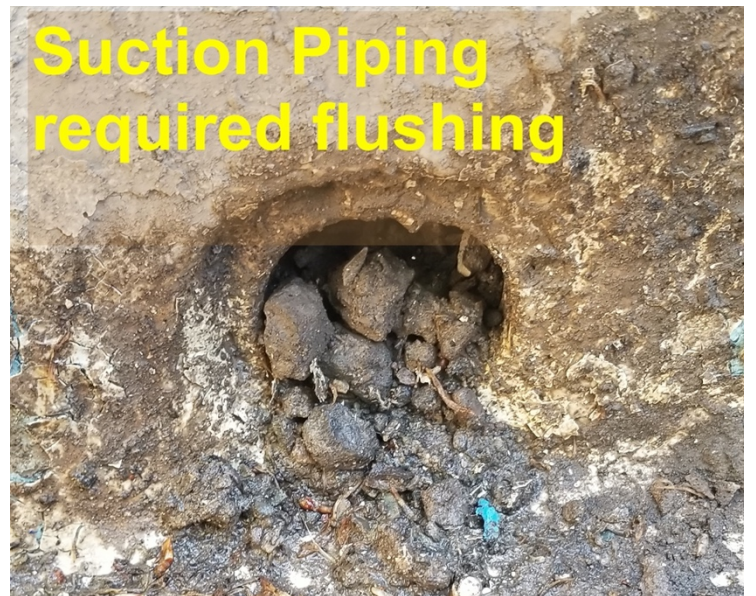
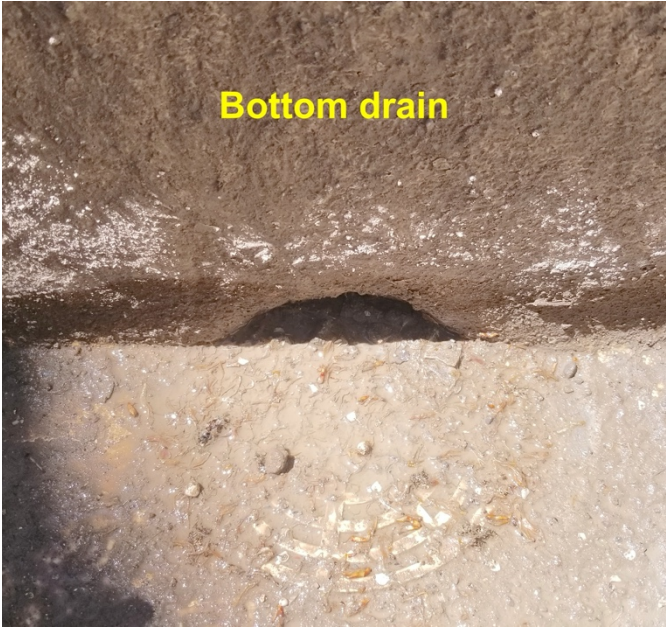
Initial Condition

The year built, and the timing of subsequent repairs and abandonment was not available at the time of inspection. Significant preparation was needed prior to inspection and pressure testing. The decking was removed from over the spa, making it accessible for a preliminary inspection. Years of dirt running into the spa coated it and in places it was becoming like concrete. I believe some of it was concrete, as even the skimmer had been filled with concrete which was subsequently chipped out for pipe testing. In addition, the pipe covers (in the spa) had been plastered over and needed chipped out so the pipes can be properly sealed for pressure testing. The pipes themselves contained pockets of a septic sludge material that required flushing out for the most accurate inspection results. Accessing all pipes in the equipment room required the removal of stored material and the existing pool filter, as it was built over pump supply piping. Inspection and testing is intended to guide decisions regarding refurbishment or replacement.
